# Manhole Inspection Summary

Manhole # S33MM\_043MH

Insp Date: **11/29/06 12:28 PM**

**Location** Address: **2101 CHARLES ST**

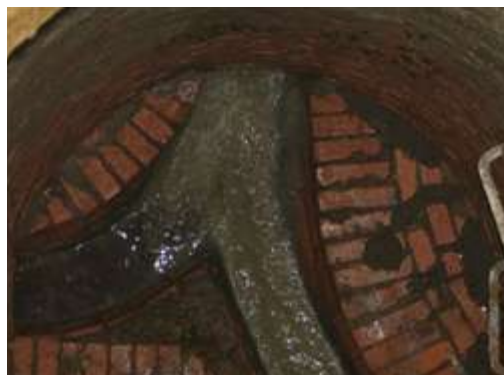
Top View

Bench debris.

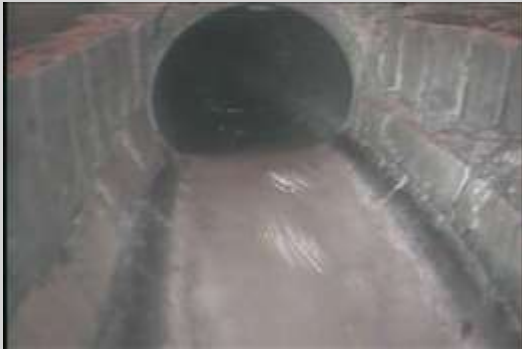
### 10 in. Circular Gravity Sewer Pipe Out @ 12 O'Clock

Invert Depth: **12.01** (ft.) Flow Characteristics: **Fast**

Deposits: ☒ None ☐ **Mud** ☐ Sludge ☐ **Debris** ☐ Grease

Infiltration: **None** Pipe Seal Cond: **Unknown**

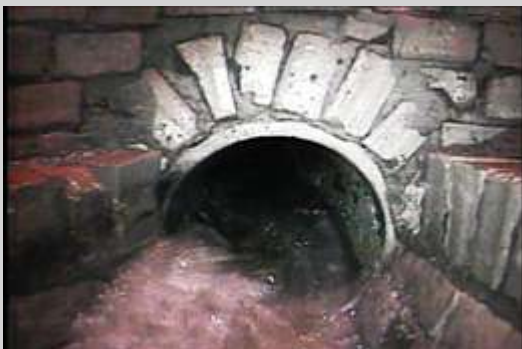
### 10 in. Circular Gravity Sewer Pipe In @ 4 O'Clock

Deposits: ☐ None ☐ **Mud** ☐ Sludge ☐ **Debris** ☒ **Grease**

Silt Depth: **0** (in.) Deposits Extent: **Light**

Infiltration: **None** Pipe Seal Cond: **Roots**

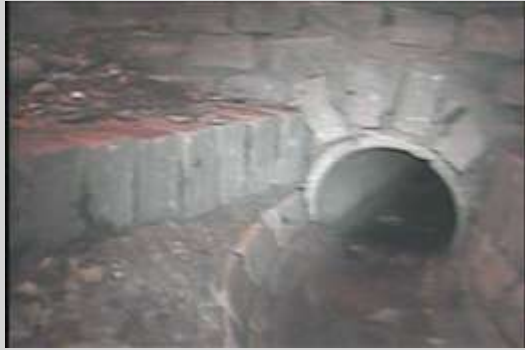
8 in. Circular Gravity Sewer

Invert Depth: **11.94** (ft.) Flow Characteristics: **Slow**

Deposits: ☐ None ☒ **Mud** ☐ Sludge ☒ **Debris** ☐ Grease

Silt Depth: **0.5** (in.)

Deposits Extent: **Light**
